Protecting Anchor River streambanks for juvenile salmon, people, and cleaner water

This article is about protecting and improving streambanks in the Silverking Campground, which is just below the Old Sterling Highway bridge, in the Anchor River State Recreation Area. There's not much streambank between the parking lot and the river channel in Silverking—as shown on the map below. What's there is important and worth protecting.

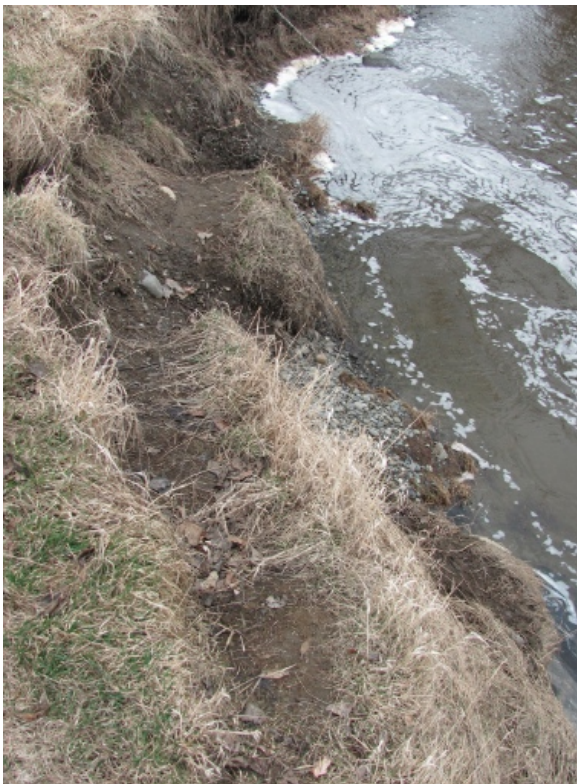
As shown in the **photo at left**, visitors walking along the river's edge destroy all the vegetation in the pathways they create, while also compacting the soil so that rainfall and runoff flow along the path, eroding it deeper instead of infiltrating into the ground. Over time, these cleared pathway areas slowly pull apart and slump down the bank into the river, where they're washed away, eliminating streamside habitat and widening the river. (As sections of river grow wider, the water gets shallower, leading to warmer water temperatures that can be dangerous for salmon.) When one trail disappears, visitors create a new pathway upslope, starting the process over.

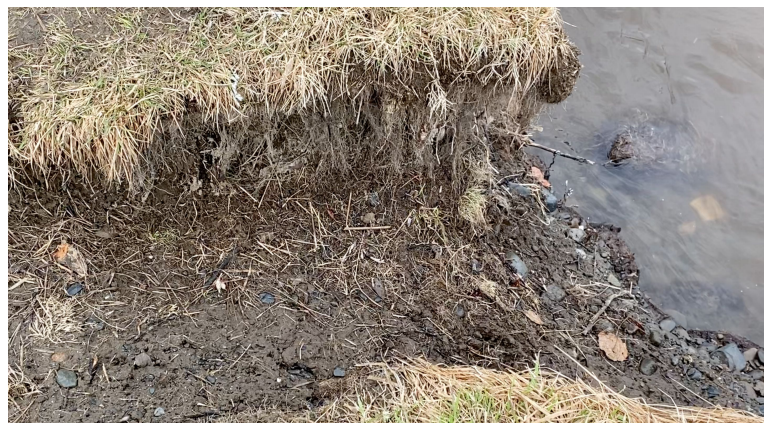
Where visitors make trails into the river—as seen in the **photo below**—or scramble or slip down the bank to access the water, they can create denuded slides that erode into deep gouges.

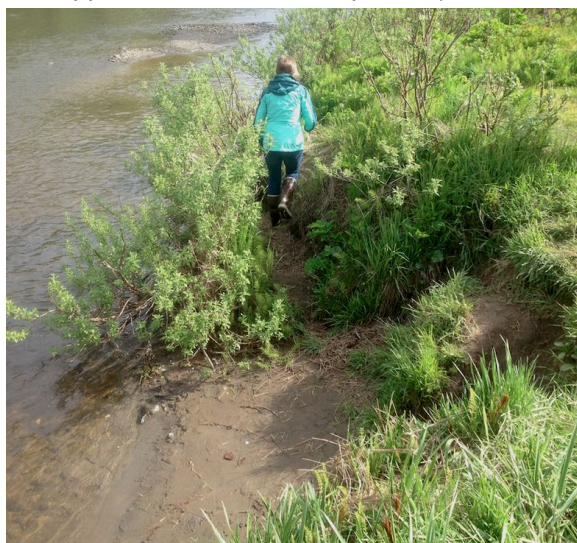
Photos below – Site 1 before revegetation

(These photos are looking upstream; the picnic table visible in the lower photo is at Campsite #14 and appears in several other photos.)

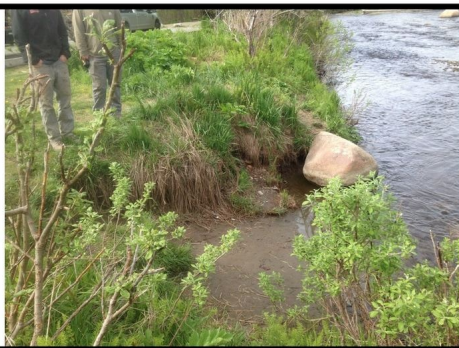
Before

This area had been excessively trampled, leaving the bank denuded and prone to erosion. Without vegetation, it offered poor habitat for juvenile salmon and little protection against natural erosion processes.

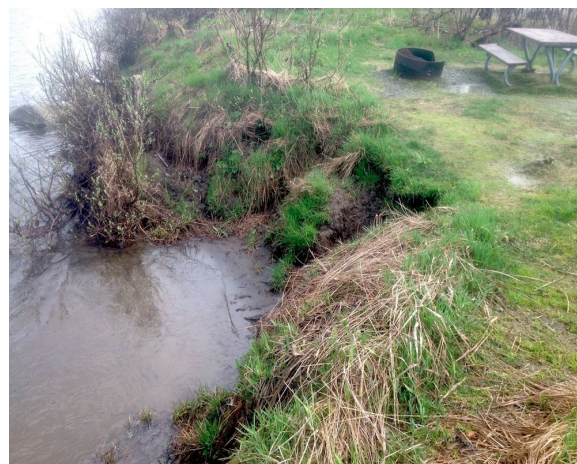
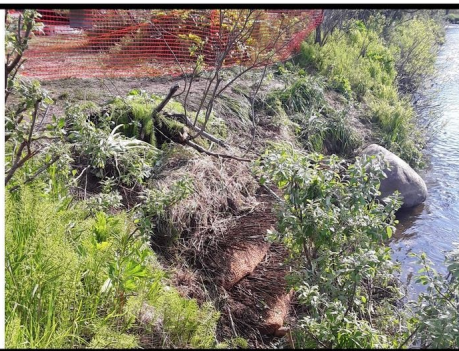
After

Thanks to the volunteers who helped install this bioengineering project, the bank now will have willows rooting to hold the bank as well as woody debris to offer habitat and hiding places for juvenile salmon.

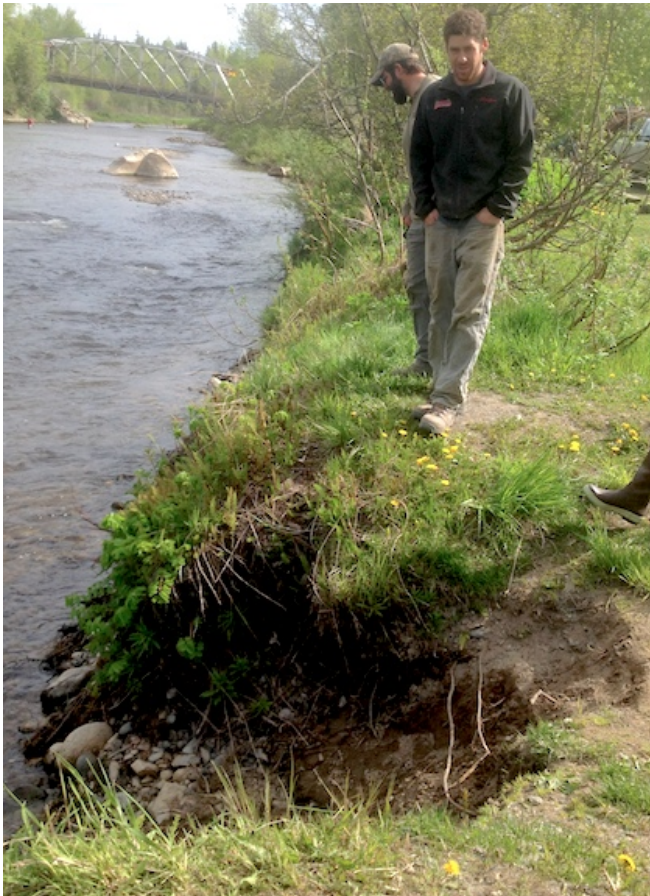
Photo top left – Site 2 before reveg, looking upstream
Photo immediately below – Site 1, a layer of willow cuttings

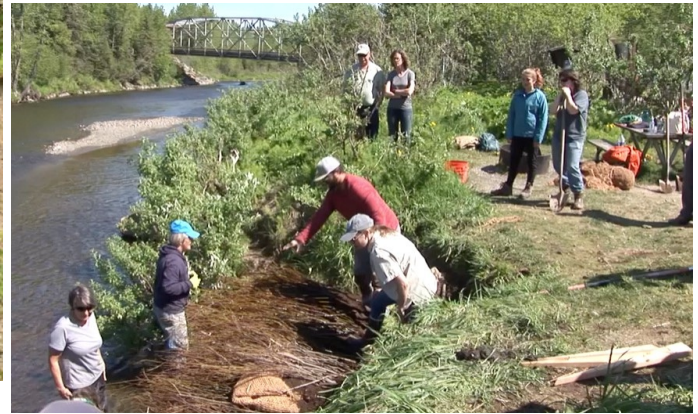
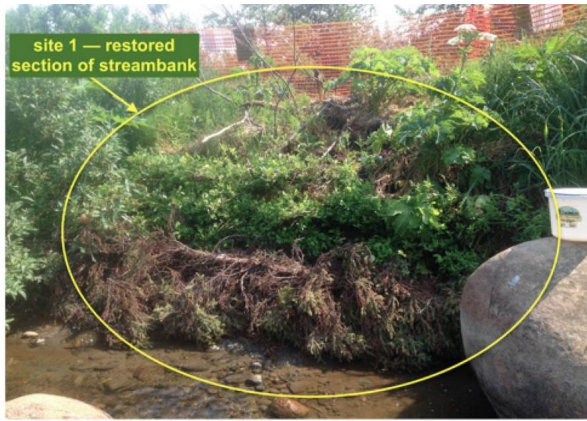
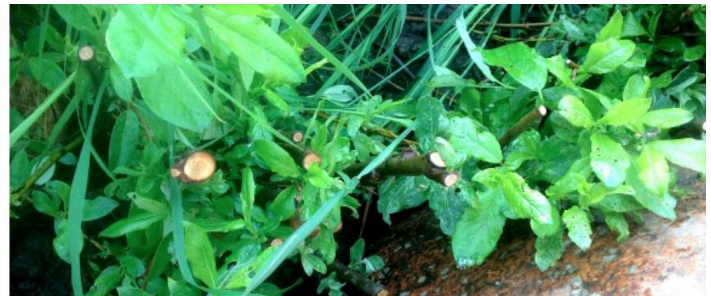
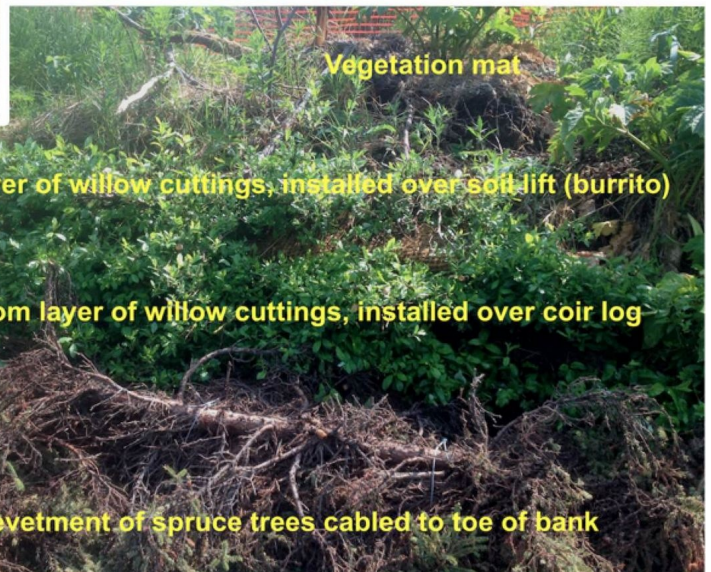
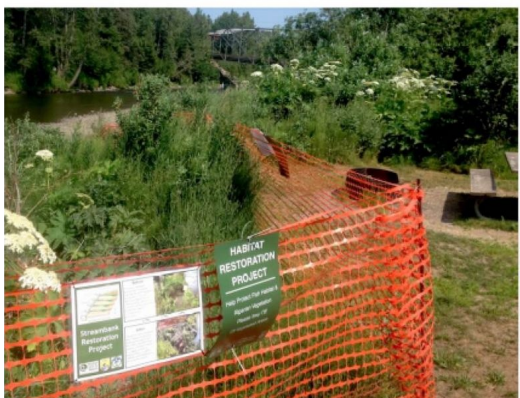
Revegetation involved creating a new vegetated stream-bank in layers, with compacted soil anchoring willow cuttings planted at an angle extending out from the bank (see **photos below**). The process can be seen step-by-step on Youtube—just search for “Anchor River Silverking Campground streambank restoration.” Layers are labeled on the **bottom photo below** from Site 1, which shows the site 1 month after installation. Temporary fencing and signage are also shown, which educated visitors about the process and protected the sites until late spring 2020. The **close up photo below** shows willow cuttings about a month after planting.

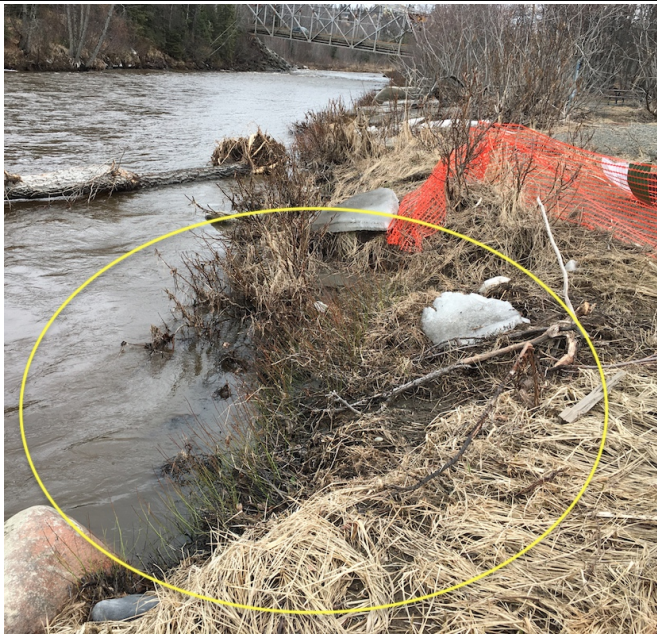
Site 1 on April 24, 2020, after ice jam flooding –
The planted area is largely intact.

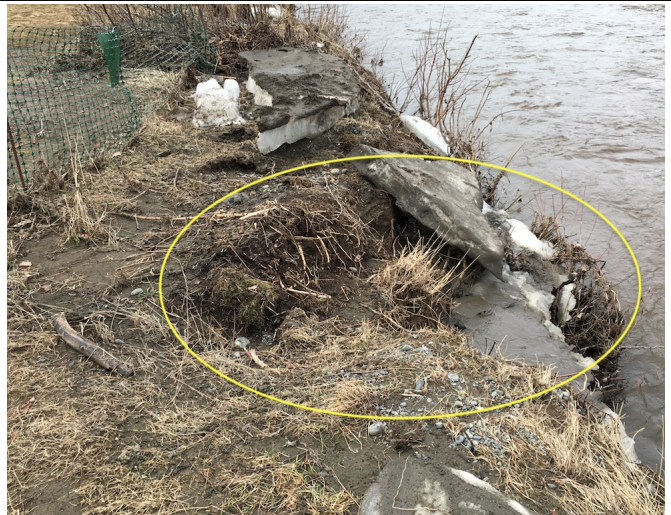
Site 2 on April 24, 2020, after ice jam flooding –
The planted area is largely intact, although some of the vegetation mat added as the top layer has washed away.

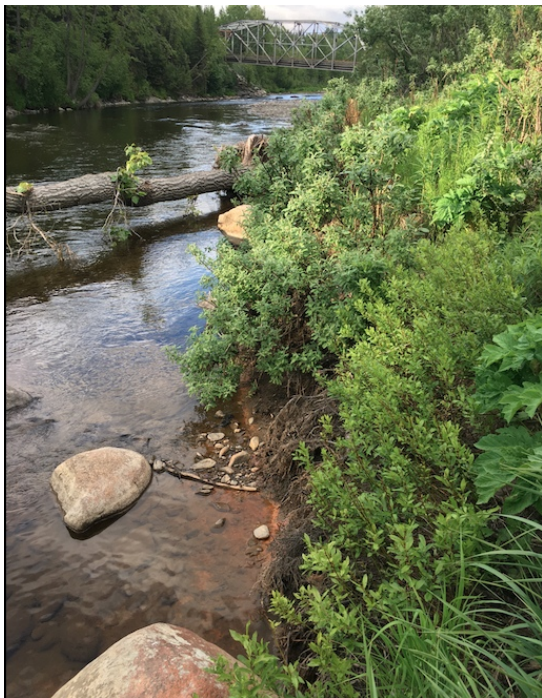
Site 1 on June 20, 2020 – The revegetated site is doing well, but visitors are creating a new steep access slide down into the river just upstream of the revegetated area.

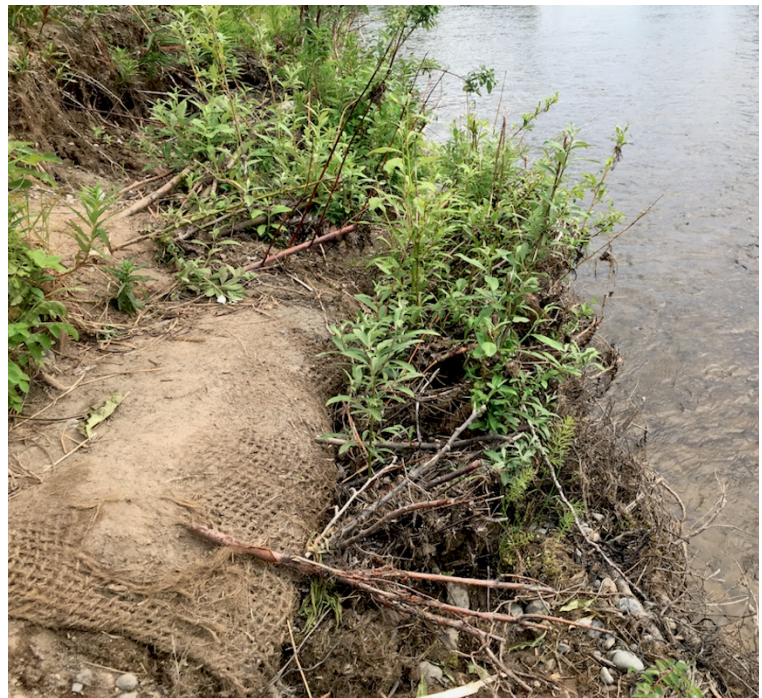
Site 2 on June 20, 2020 – Winter erosion exposed this “soil lift,” installed above the bottom layer of willow cuttings; visitors then began using it as a step to get down to the river, further destroying vegetation and causing accelerated erosion.

When the temporary fencing was removed around the sites, the soil lifts became handy steps down the bank for visitors wanting to get into the river. This kind of activity was anticipated and is the reason for planning to install stairs into the river, as outlined below.

To help protect streambank vegetation, in summer 2021 State Parks will install three access improvements to serve visitors to Silverking Campground: (1) a set of stairs for getting down into the river, (2) a platform for gathering or sitting by the water's edge, and (3) a gently sloping, geoweb-protected trail to the river's edge below the bridge. Approximate locations of these improvements are shown in orange at right.

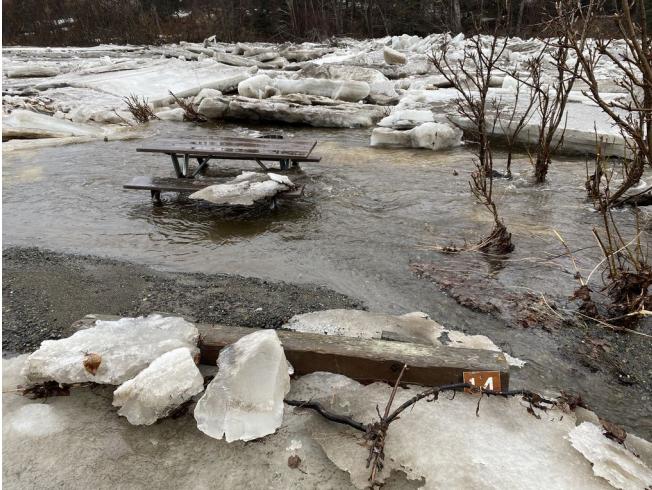
April 22, 2021 – Ice jam flooding, Campsite #14. The revegetated area is covered by floodwaters and ice.

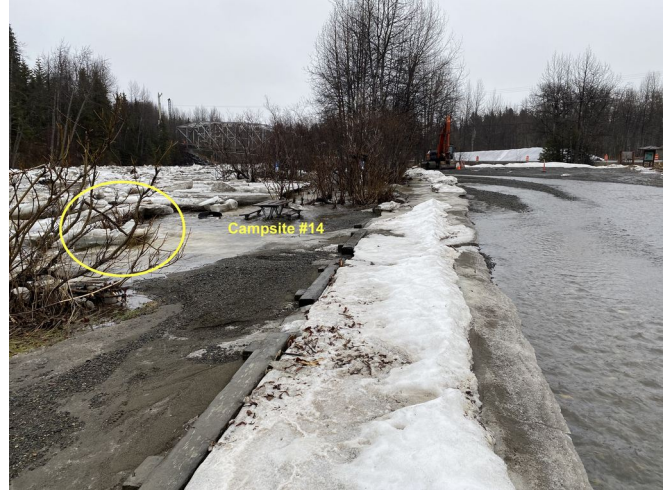
April 22, 2021 – Circle shows approximate location of revegetated area.

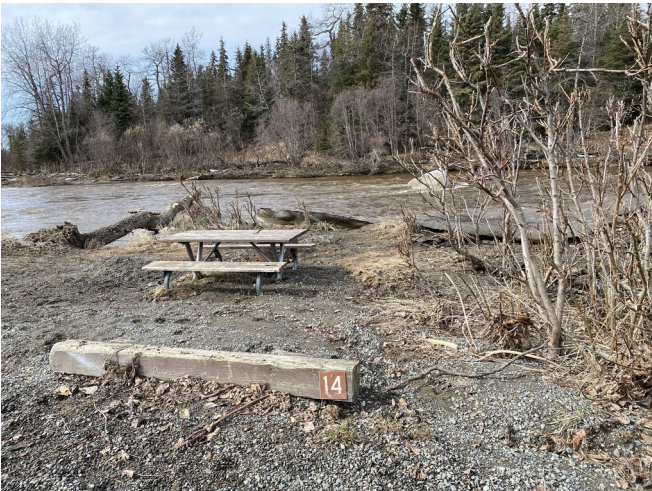
April 29, 2021 – Campsite #14 after floodwater receded.

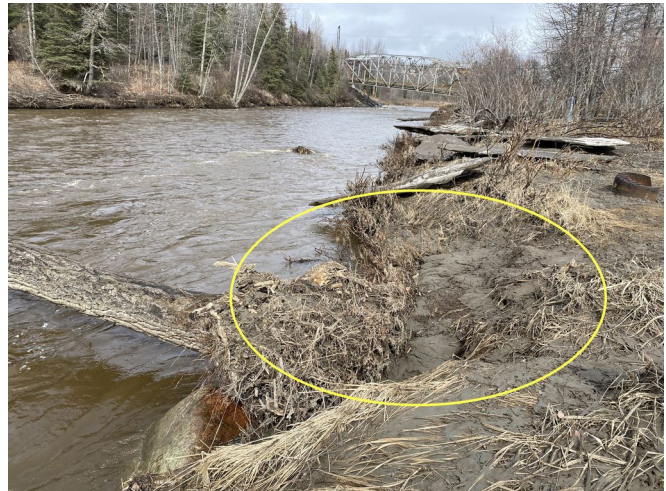
April 29, 2021 – Approximate revegetated area is circled.

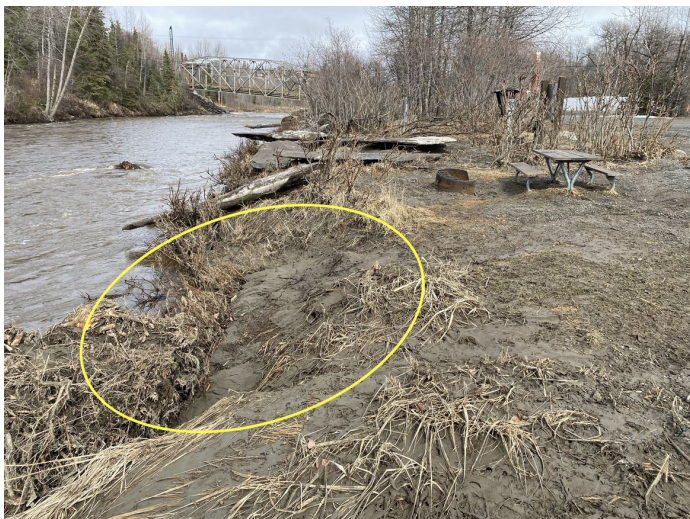
April 29, 2021 – Approximate revegetated area is circled. Site 1 is still filled in, and soon we'll know whether the remaining willow cuttings have survived.

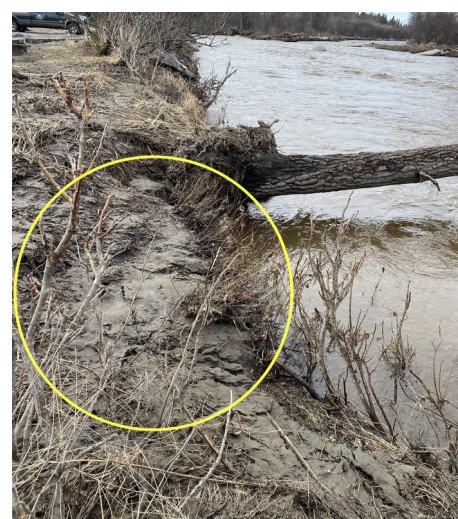
April 29, 2021 – Approximate revegetated area is circled; willow cuttings are visible. The tree was deposited by floodwaters.

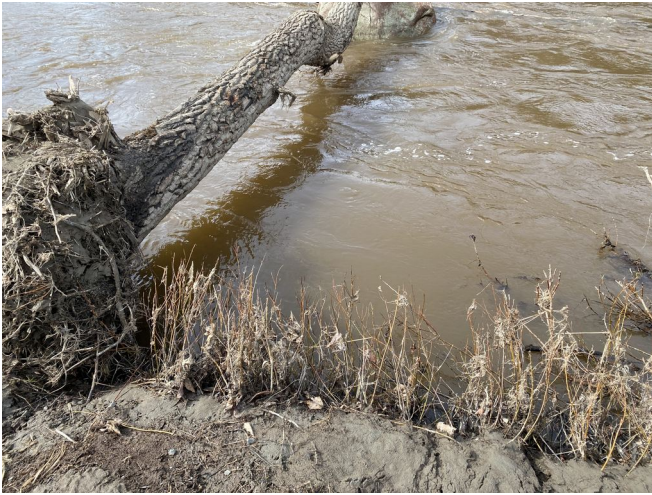
April 29, 2021 – Willow cuttings visible at Site 1.

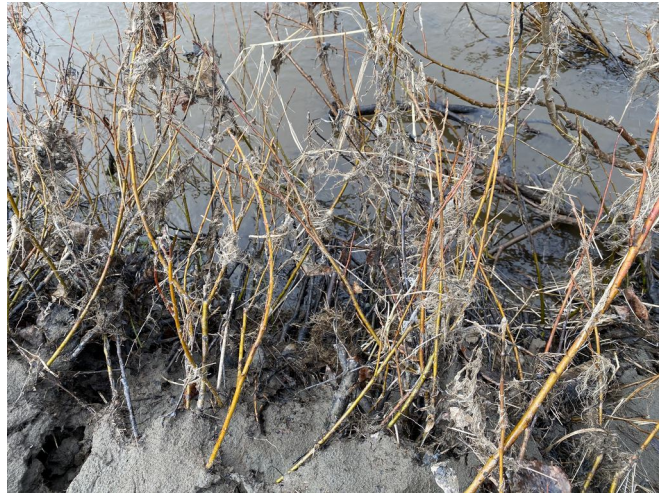
April 29, 2021 – Close up of willow cuttings at Site 1.

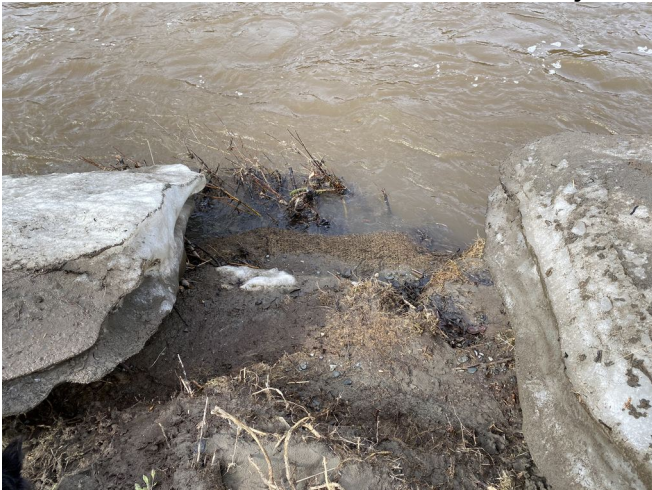
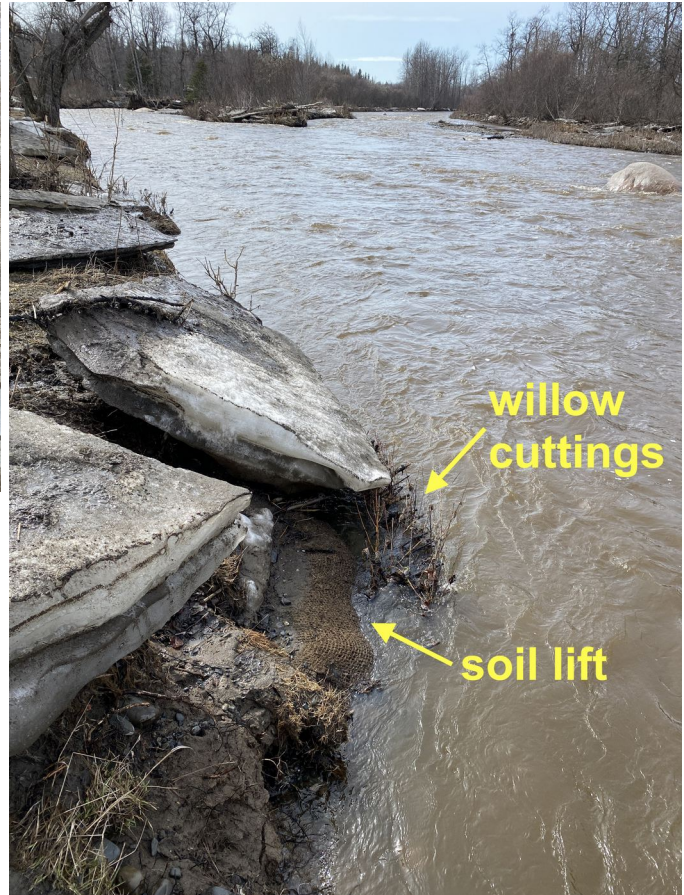
Site 2 after ice jam flooding – April 29, 2021.

As shown earlier, during summer 2020 the soil lift at Site 2 had become a step for scrambling down the bank and into the river. In **photos above and at right**, the soil lift installed in 2019 above the bottom layer of willow cuttings can still be seen, as can the willow cuttings below it. Willow cuttings above the soil lift have been destroyed.

As vegetation greens up in 2021 and river water level drops, we will be able to determine whether any willow cuttings at Site 2 have survived.

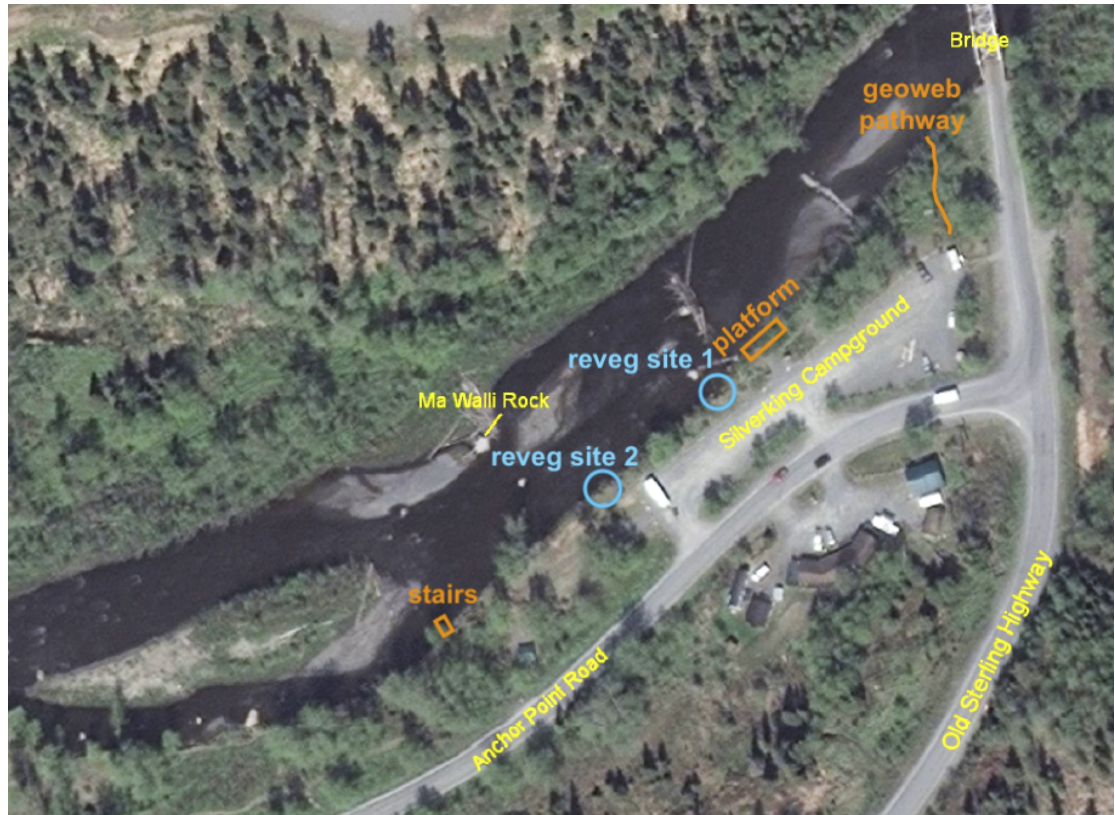
The photo also shows the locations of the two sites revegetated in 2019. (Again, notice how little streambank is left between the Silverking parking lot and the river channel.)

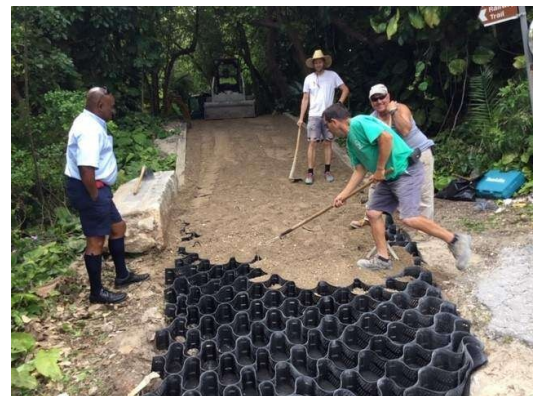
Stairs will give visitors access into the river near a fishing area: at low water, anglers will be able to walk into the channel, cross to the nearby island, and cast into the deeper channel on the far (north) side of the island. The platform will allow individuals and groups to gather at the water's edge and enjoy what's going on without damaging streambank vegetation. The plan is to include a ramp onto the platform so visitors with mobility issues can also access the platform. Finally, a geoweb-protected trail will be located where the slope down to the river is relatively gentle and where a trail to the water's edge makes sense. Geowebbing comes in different styles and thicknesses—an example of **a geoweb trail is shown at right**.

Geoweb is backfilled with soil and gravel to protect the trail's surface from compaction and erosion, which also makes the trail smoother and less prone to becoming muddy. The trail will connect to a graveled trail that the Department of Transportation will install under the new bridge as part of bridge replacement. During bridge construction, many changes will occur in Silverking Campground, so once construction is complete, planning partners will look at what kinds of additional improvements can be made in Silverking.
